BAYOU PASS VILLAGE
PROPERTY OWNERS' ASSOCIATION, INC.
FULL RESERVE STUDY REPORT

For 30-Year Projection Period: FY 2023 through FY 2053

Reference #: 423.23

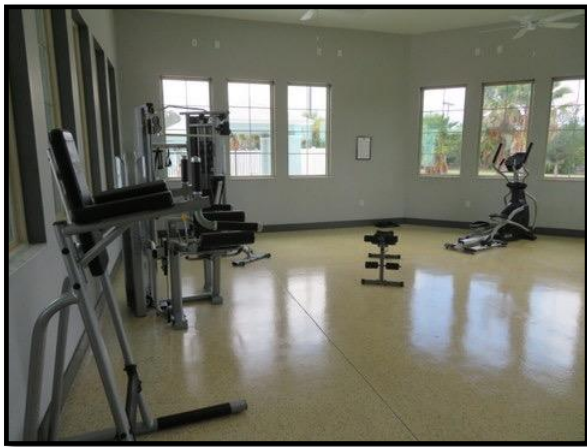
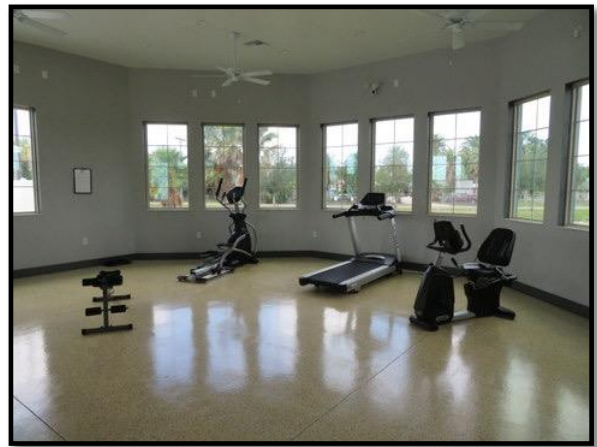
Bayou Pass Village maintains various pieces of strength training and cardio exercise equipment. Exercise equipment has a useful life of up to 15 years. The Association should budget for replacement of the equipment by 2031 and again by 2043. Bayou Pass should fund interim repairs through the operating budget.

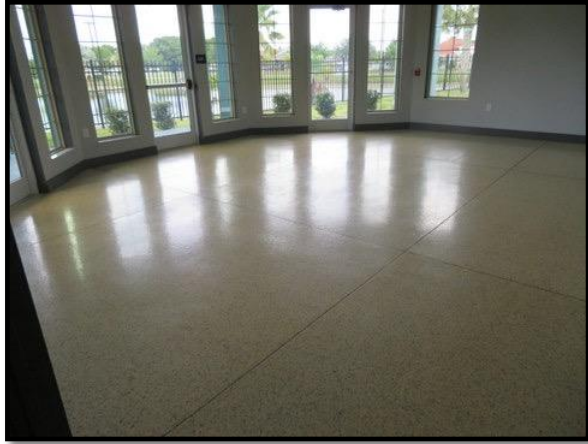
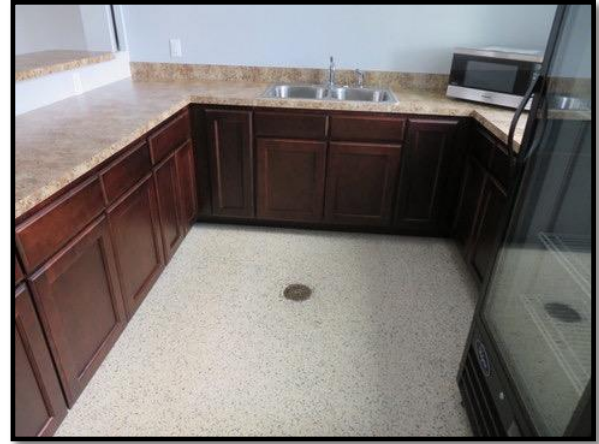
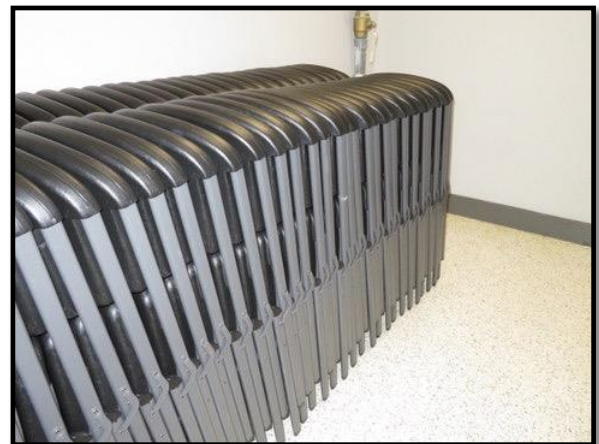
The Association maintains approximately 3,200 square feet of interior finished area. The interior components comprise paint finishes, terrazzo floor coverings, appliances and furnishings, plumbing and electrical fixtures. The interior components are in good overall condition at an age of four years. The useful lives of these interior components vary. However, in order to maintain continuity, the Association should coordinate replacement of all these components every 25 years. Bayou Pass Village should budget for a complete renovation by 2043. The Association should maintain the floors through the operating budget.

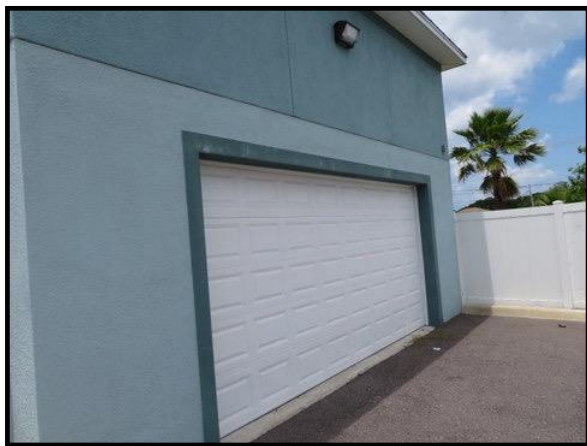
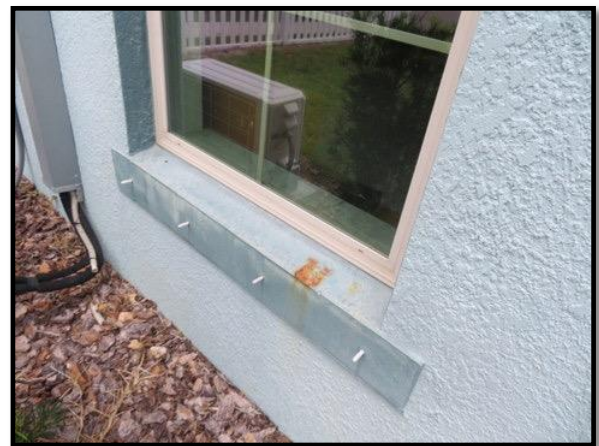
The paint finishes are in fair overall condition at an age of four years. Paint finishes have a useful life from five- to seven-years. The first cycle typically has a lower useful life due to lower builder grade paint and absorption. Bayou Pass Village should budget for the next paint finish application by 2024 and every seven years thereafter. The Association should also plan for weatherizing the window sealants and any exterior penetrations as needed in conjunction with paint finish applications.

Figure 1 – Faded Paint at Maintenance Building

Figure 2 - Faded Paint at Maintenance Building

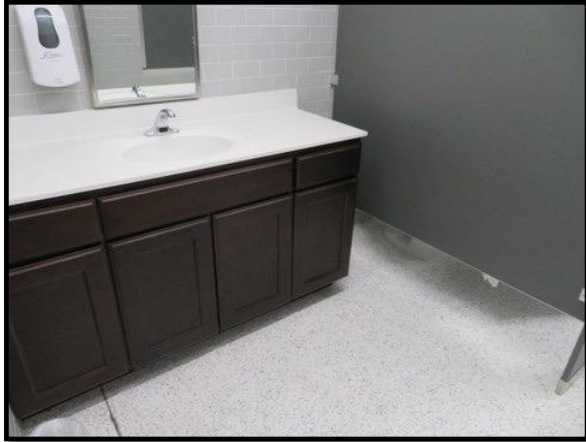
Figure 1 – Clubhouse Rest Room

There are four rest rooms within the Blossom Bayou clubhouse. The rest rooms comprise tile wall coverings plumbing fixtures partitions, cabinets, and countertops. These rest room components have a useful life from 15- to 20-years. Bayou Pass Village should budget for renovations of the rest rooms by 2032 and again by 2047.

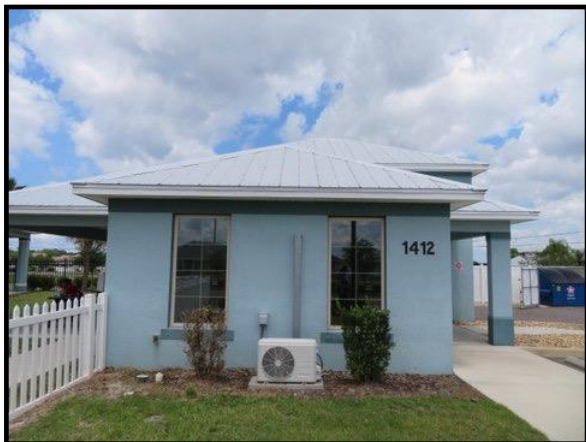
There are approximately 80 squares of corrugated metal roofs located at the Blossom Bayou amenity center. This quantity includes the maintenance garage and pavilions. Corrugated roof panels are fastened by screws. The metal roofs are in good overall condition at an age of four years. Metal roofs of this type have a useful life of up to 25 years with the benefit of periodic maintenance. This maintenance includes sealing the exposed fasteners as needed. The Association should budget for replacement of the metal roofs by 2044.

Figure 1 – Maintenance Building

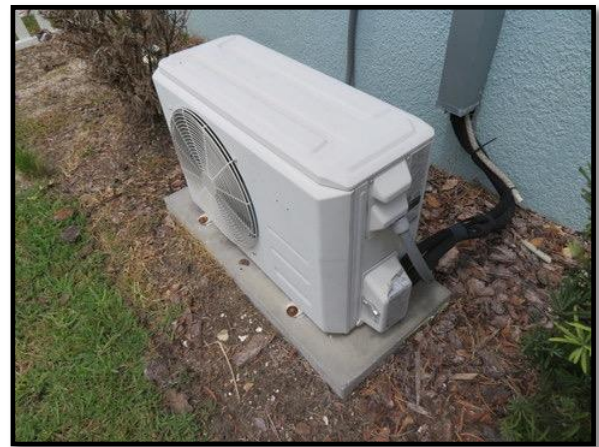
The Blossom Bayou clubhouse utilizes five split systems for heating, ventilating and air conditioning. Two mini split systems were not operational at the time of inspection. Split systems have a useful life from 10- to 15-years. Bayou Pass Village should budget for replacements by 2029 and every 10 years thereafter.

Figure 1 – Mini Split Air Handler

Figure 2 - Mini Split Condenser

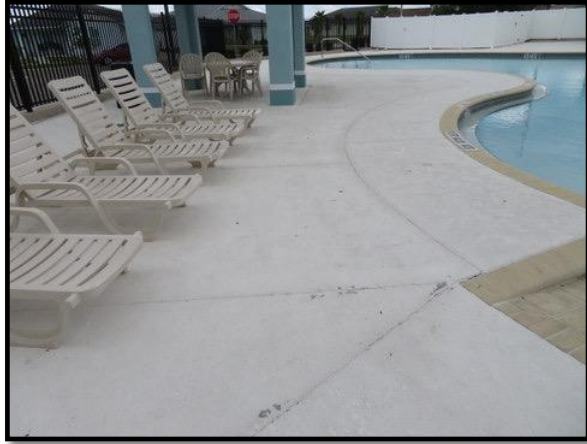
Figure 1

The Blossom Bayou pool deck comprises approximately 11,790 square feet of concrete. Concrete pool decks have a long useful life with the benefit of periodic maintenance. Periodic maintenance includes a slip resistant coating application. Bayou Pass Village should budget for the next coating application in 2024 and every three- to five-years thereafter.

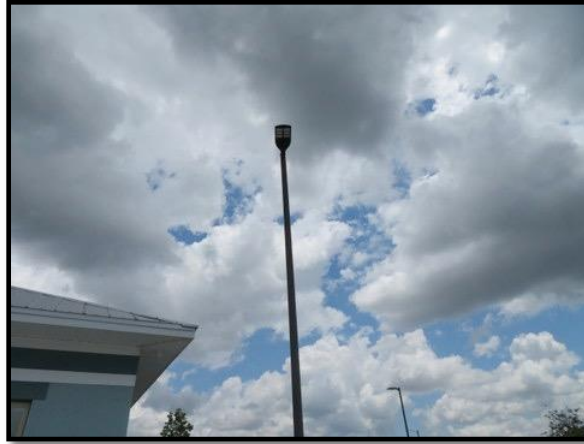
The Association maintains eight light poles and fixtures located around the Blossom Bayou amenity center. Light poles have a useful life of up to 25 years. Bayou Pass Village should budget for replacements by 2044. Our cost includes an allowance for replacement of the pole, base, fixture and minor electrical repairs at the time of replacement. Interim replacement of light bulbs and/or fixtures should be funded through the operating budget on an as needed basis.

Figure 1 – Typical Light Pole and Fixture

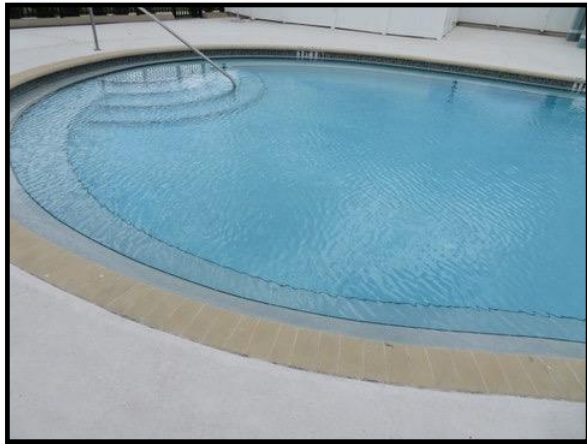
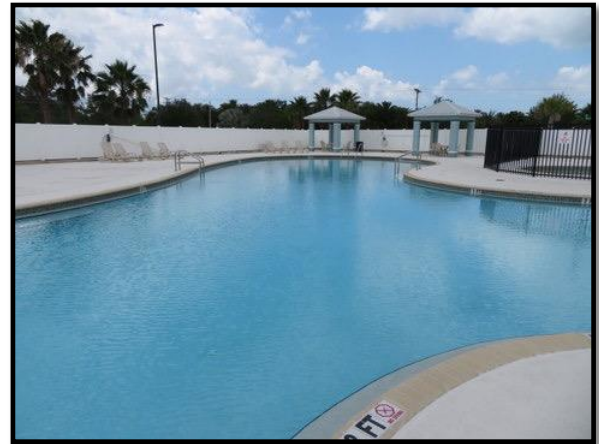
The Blossom Bayous pool comprises approximately 4,150 square feet of horizontal pool finishes. The pool finish is in fair overall condition at an age of four years. The pool finish has a useful life from 10- to 15-years. Bayou Pass Village should budget for resurfacing of the pool finish by 2029 and every 10 years thereafter. Typically minor upgrades will be needed to bring the pool up to current code.

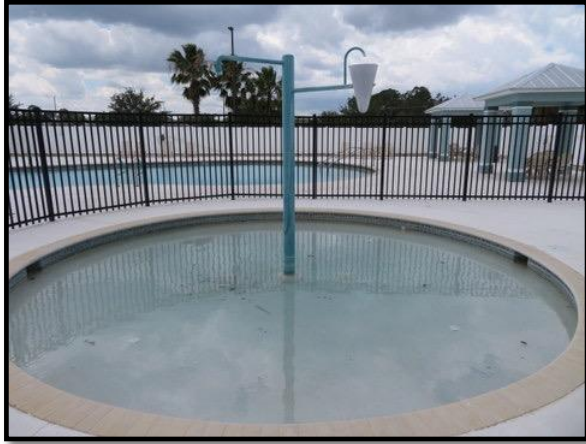
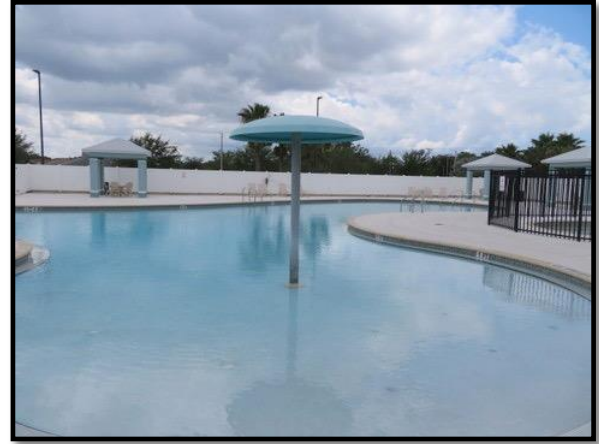
The pool area utilizes two water features. The water features are in good condition at an age of four years. The water features have an estimated useful life of up to 15 years. Bayou Pass Village should budget for replacements by 2034 and again by 2049.

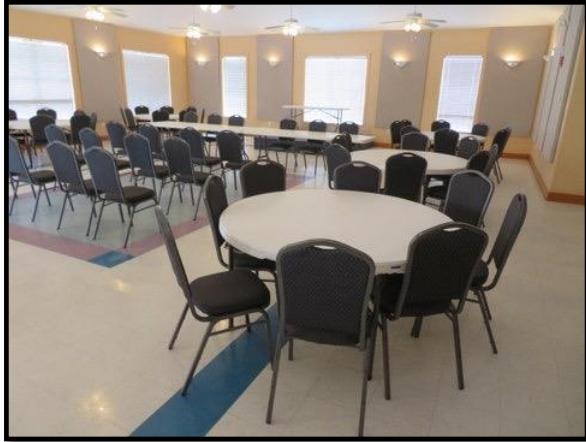
Figure 1

The Dorothy Duke clubhouse includes a fair amount of furniture. The furniture is in fair overall condition at various ages. The useful lives of these components vary up to 20 years. Bayou Pass Village should budget for phased replacements of up to thirty-three percent (33%) every six years beginning in 2024.

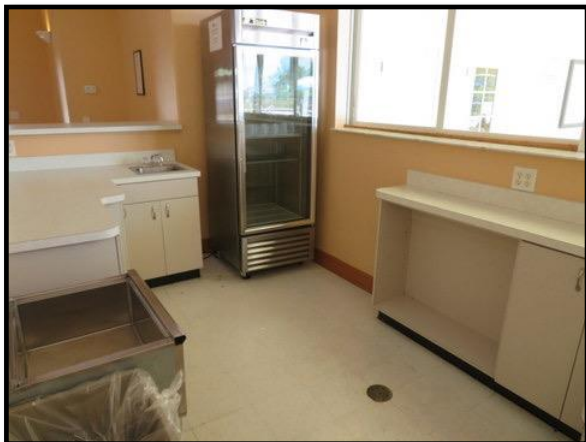
Figure 1

The Dorothy Duke clubhouse comprises 3,300 square feet of interior finished area. The interior components comprise paint finishes, vinyl floor coverings, appliances and furnishings, plumbing and electrical fixtures. The interior components are in fair overall condition. The useful lives of these interior components vary. However, in order to maintain continuity, the Association should coordinate replacement of all these components every 30 years. Bayou Pass Village should budget for a partial renovation followed by a complete renovation by 2039.

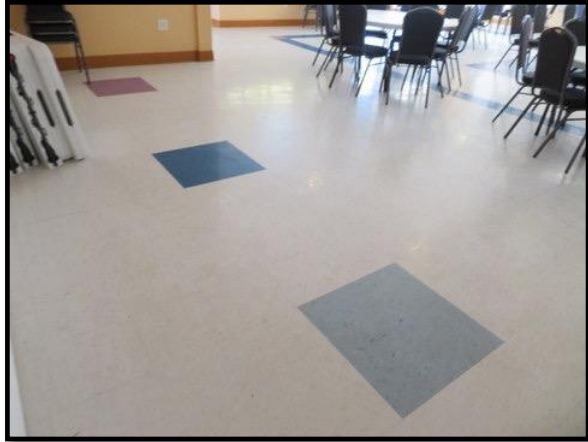
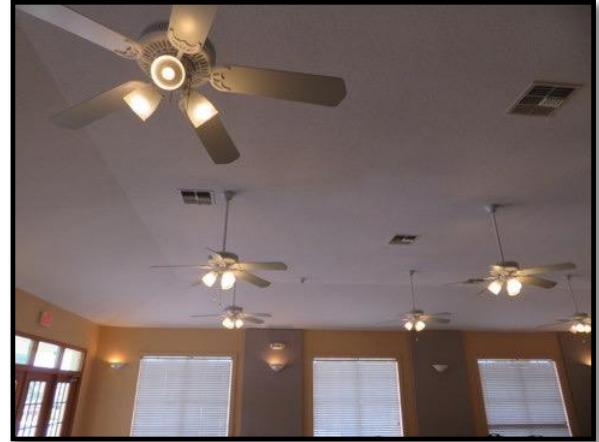
A partial renovation includes paint finishes, floor coverings, appliances and electrical fixtures as needed. Bayou Pass Village should budget for a partial renovation in 2024 and every 10- to 15-years thereafter except when a complete renovation occurs.

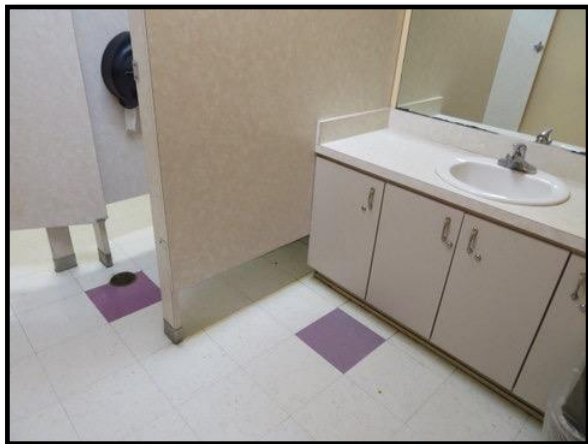
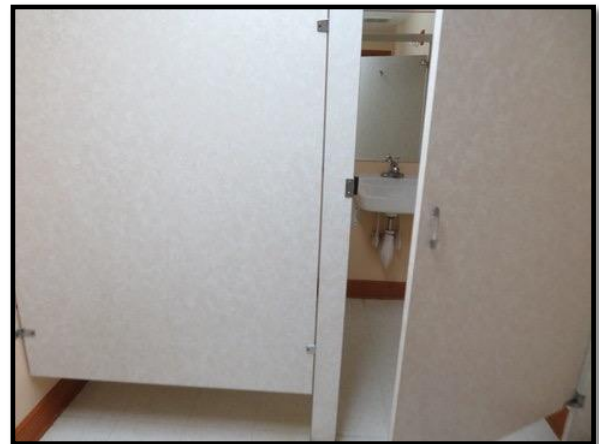
There are four rest rooms located within the Dorothy Duke clubhouse. The rest rooms comprise plumbing fixtures, partitions, cabinets, and countertops. The rest rooms are mostly original and in fair condition overall. These rest room components have a useful life from 15- to 20-years. Bayou Pass Village should budget for renovations of the rest rooms in 2023 and again by 2041. The Association should comply with the Americans with Disabilities Act (ADA).

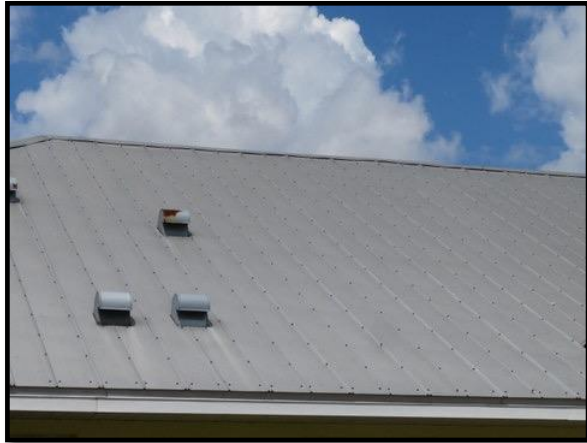
There are approximately 75 squares of corrugated metal roofing located atop the Dorothy Duke clubhouse and playground pavilion. Roof panels are fastened by screws. The metal roofs are original and in fair overall condition. As previously mentioned, metal roofs of this type have a

useful life of up to 25 years with the benefit of sealing the exposed fasteners periodically. The Association should budget for replacement of the metal roofs by 2030.

Figure 1 – Clubhouse Roof

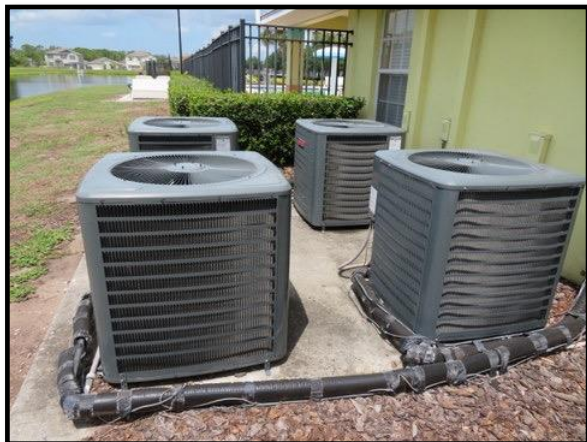
The clubhouse utilizes four split systems for heating, ventilating and air conditioning. The split systems are in good condition at an age of two years. As previously mentioned, split systems have an estimated useful life from 10- to 15-years. Bayou Pass Village should budget for replacements by 2033 and again by 2045.

Figure 1 – Split System Condensing Units

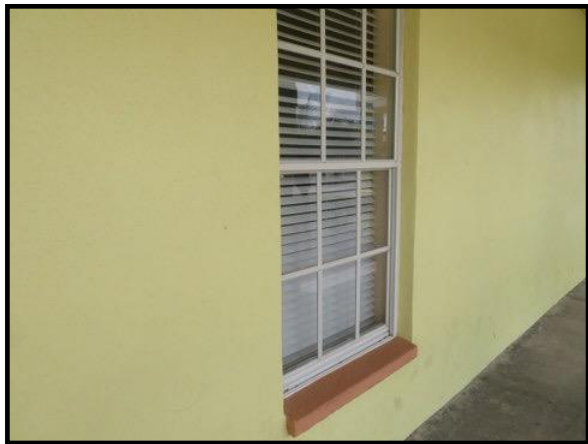
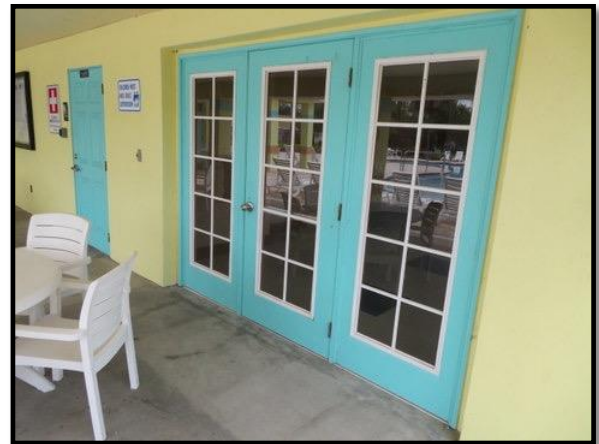
The windows and doors of the Dorothy Duke clubhouse comprise 640 square feet. The windows and doors are original and in fair overall condition. As previously mentioned, windows and doors have a useful life of up to 40 years. There will be a cost savings with coordinated replacement. Bayou Pass Village should budget for replacement of the windows and doors by 2045.

Figure 1 – Window

Figure 2 - Doors

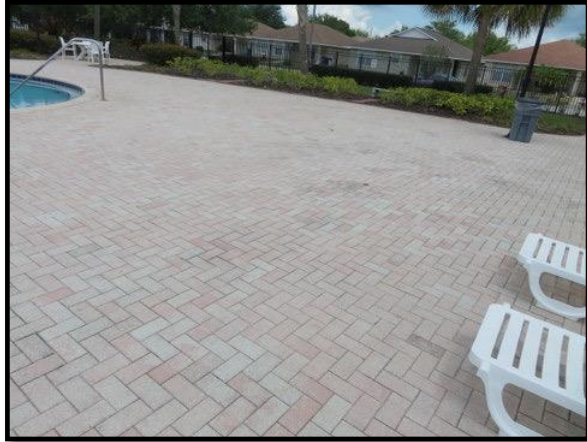
Figure 1

The Dorothy Duke pool deck comprises 5,815 square feet of pavers. The pavers are original and in good overall condition. Pool deck pavers have a useful life from 20- to 30-years with the benefit of periodic maintenance. See Line Item 40 “**Pavers, Sealer Applications**” for this maintenance recommendation. Bayou Pass Village should budget for replacement of the pavers by 2036.

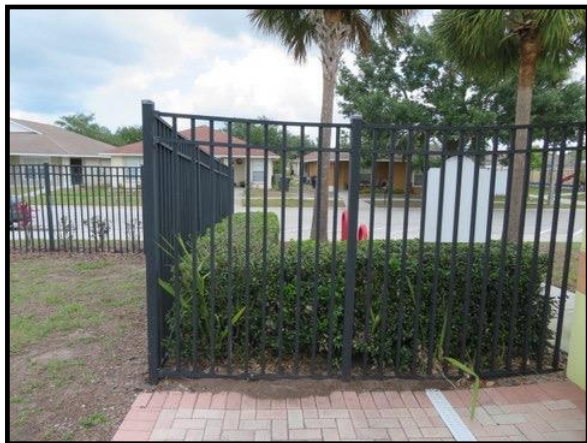
Approximately 495 linear feet of aluminum fence surrounds the Dorothy Duke pool area and playground. These fences are original and in fair overall condition. As previously mentioned, the finish on aluminum fences is relatively maintenance free and they have a useful life of up to 25 years. Bayou Pass Village should budget for replacement of the aluminum fences by 2030.

Figure 1 – Fencing

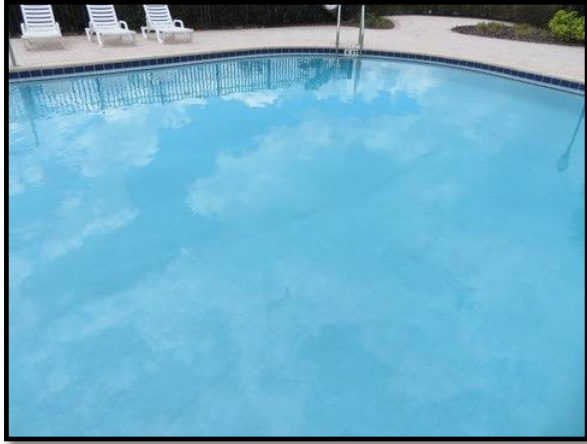
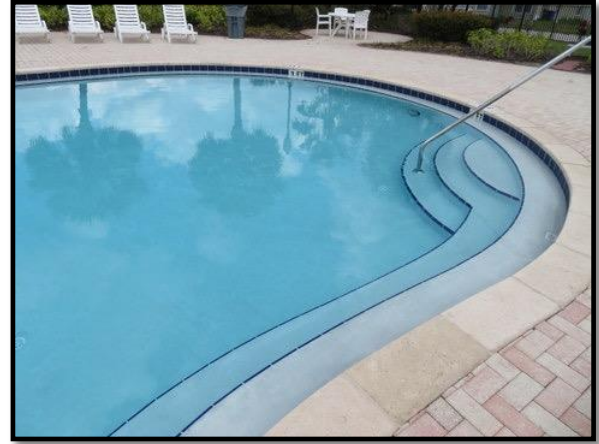
The Dorothy Duke pool comprises approximately 1,900 square feet of horizontal finish. This pool finish is in fair overall condition at an age of one year. The pool finish has a useful life from 10- to 15-years. Based on the warranty, Bayou Pass Village should budget for resurfacing of the pool finish by 2032 and every 10 years thereafter. Potential repairs to the underlying pool structure may raise the estimate of cost.

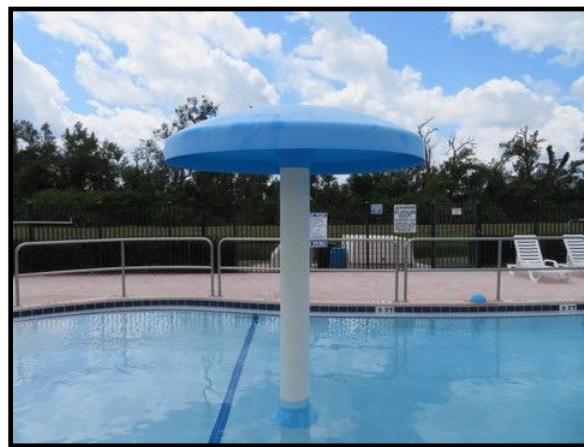
Figure 1

The pool area utilizes a water feature. The water feature is mostly original and in good condition overall. The Board reports that the Association painted this water feature since the last 2020 Reserve Study Update. Based on the condition, Bayou Pass Village should budget for replacement by 2030 and again by 2045.

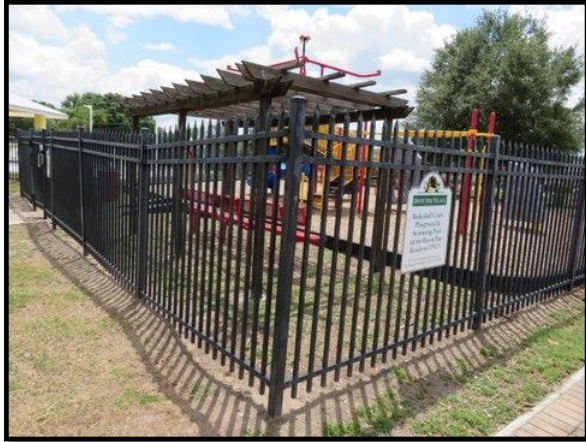
Figure 1

There are approximately 730 linear feet of aluminum fence that surrounds the Peaceful Palm amenity center. This fence is in fair overall condition at an age of 12 years. Bayou Pass Village should budget for replacement of this fence by 2036.

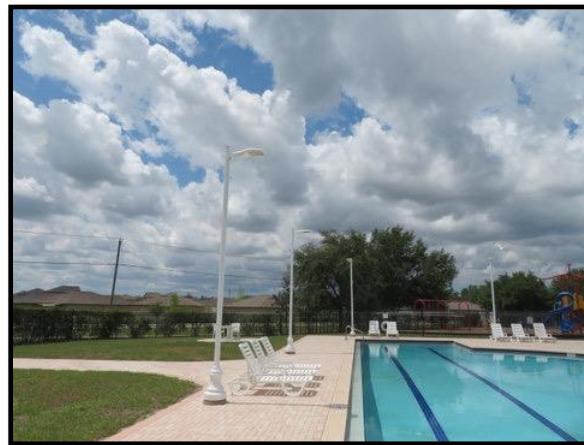
Figure 1

There are six light poles and fixtures located at the Peaceful Palm pool area. The light poles and fixtures are original and in fair to good condition overall. The Association should budget for replacement of these light poles and fixtures by 2036.

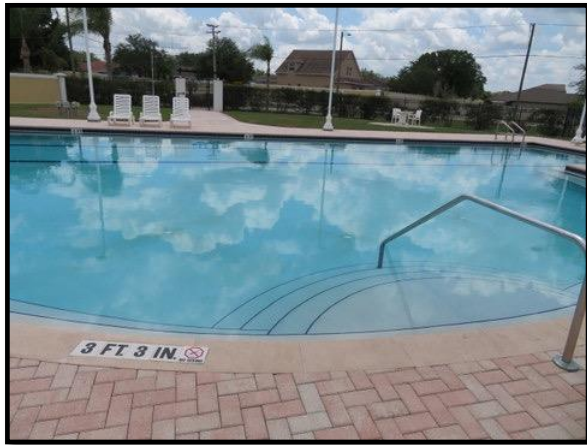
The Peaceful Palm pool finish comprises approximately 2,150 square feet. This pool finish is in fair overall condition at an age of 12 years. As previously mentioned, pool finishes have a useful life from 10- to 15-years. Bayou Pass Village should budget for resurfacing of the pool finish in 2024 and every 10 years thereafter. Typically, minor upgrades will be needed to bring the pool up to current code. The Association should ensure that bidding contractors have an active license with a

“CPC” designation. An allowance for replacement of the waterline tile is included in the estimate of cost. Potential repairs to the underlying pool structure may raise the estimate of cost.

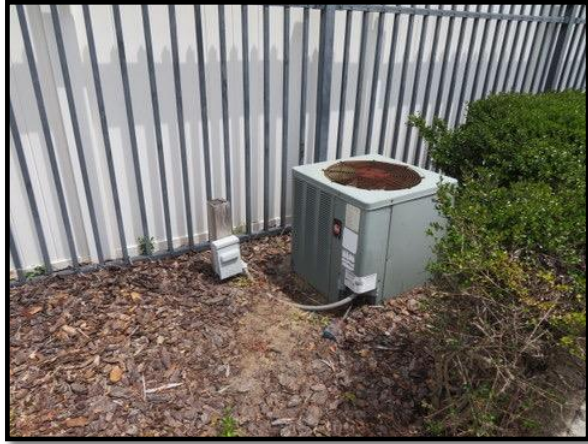
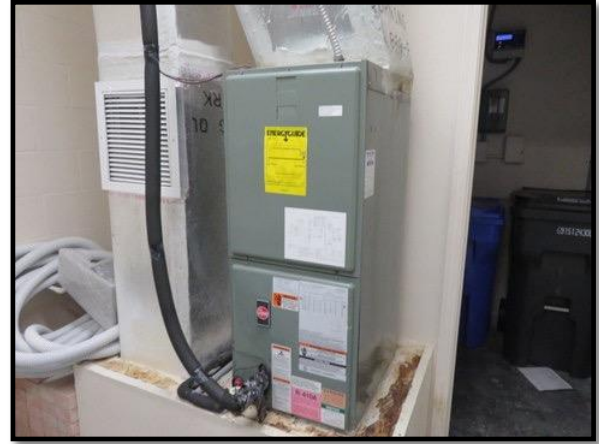
The cabana utilizes a split system for heating, ventilating and air conditioning. The split system was operational at the time of the site visit. As previously mentioned, split systems have an estimated useful life from 10- to 15-years. Bayou Pass Village should budget for replacement of the cabana split system in 2024 and every 12 years thereafter.

Figure 1 – Split System Condensing Unit

Figure 2 - Split System Air Handling Unit

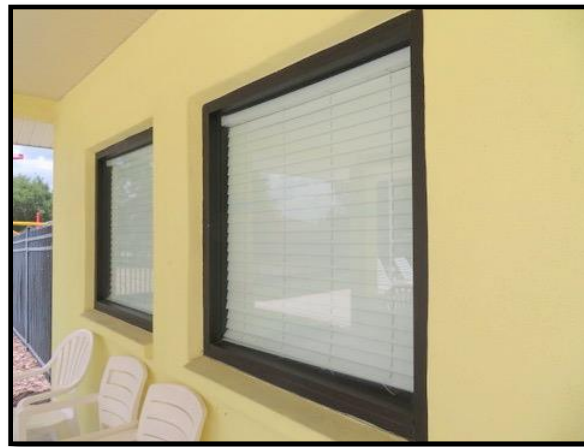
Figure 1

The windows and doors of the cabana comprise 160 square feet. The windows and doors are original and in fair overall condition. Bayou Pass Village should budget for replacement of the windows and doors by 2045.

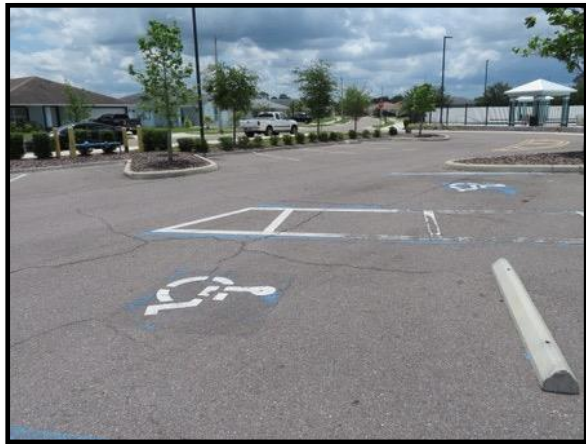
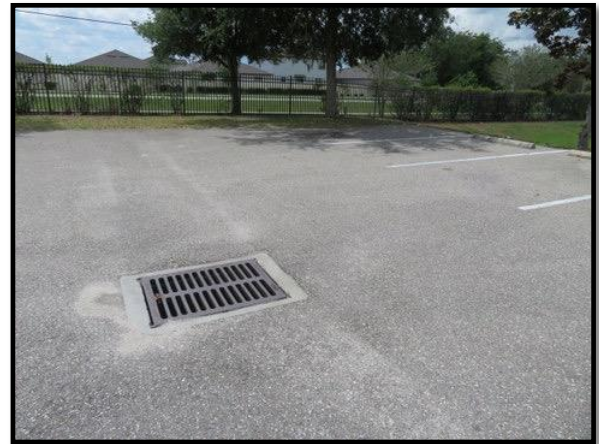
The asphalt pavement is original and in good to fair overall condition. Areas of cracks are noted. The Association should repair any isolated areas of deteriorated pavement prior to asphalt coating applications.

Figure 1 – Blossom Bayou Parking Area

Figure 2 – Peaceful Palm Parking Area

The asphalt coating has a useful life of five- to eight-years. Bayou Pass Village should plan for an application of pavement preservation in 2024. Subsequent cycles are likely every five - to eight-years thereafter except when replacement occurs.

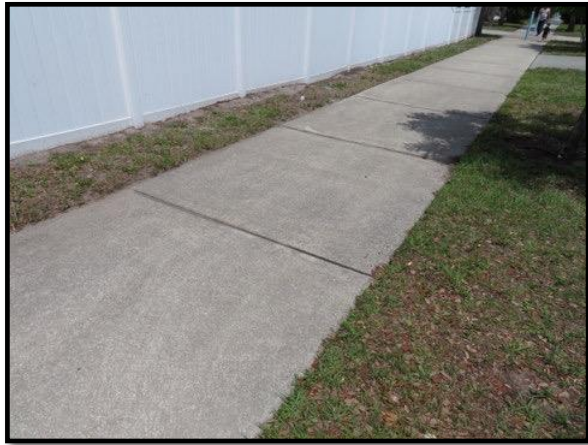
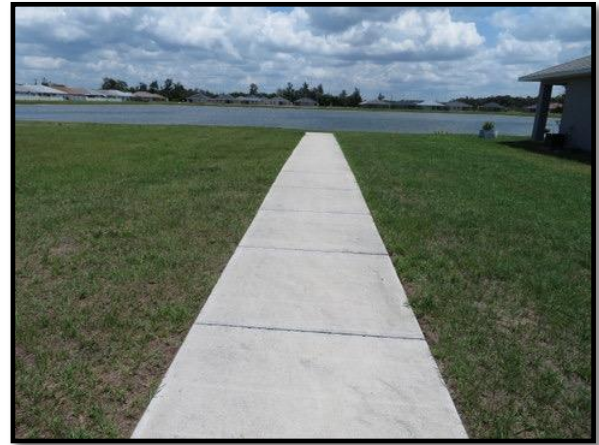
should conduct annual inspections of the concrete flatwork to identify potential trip hazards. The estimate of costs are based on 3,000 psi (pounds per square inch) concrete with reinforcing. The costs noted in the expense spreadsheet Appendix A also include removal. In addition, the Association should fund interim grinding of the minor areas of settlement and or displacement through the operating budget as needed. Keeping the trees trimmed will minimize the amount of repairs needed.

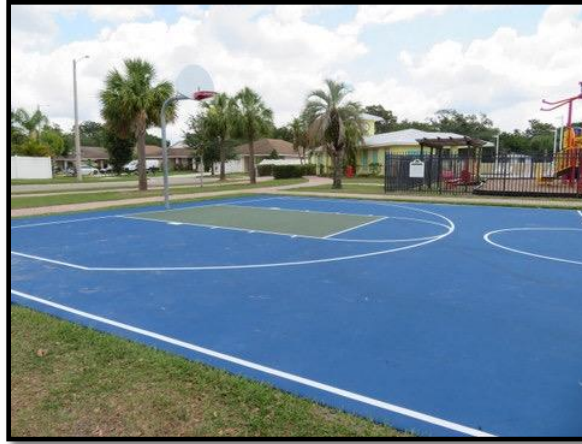
Figure 1

The Association maintains a basketball court that comprise 345 square yards of surface area. The court requires repairs and a color coat application every four- to six-years to maintain the playing surface. The color coat is in good overall condition at an age of one year. Bayou Pass Village should budget for color coat applications by 2026 and every four years thereafter.

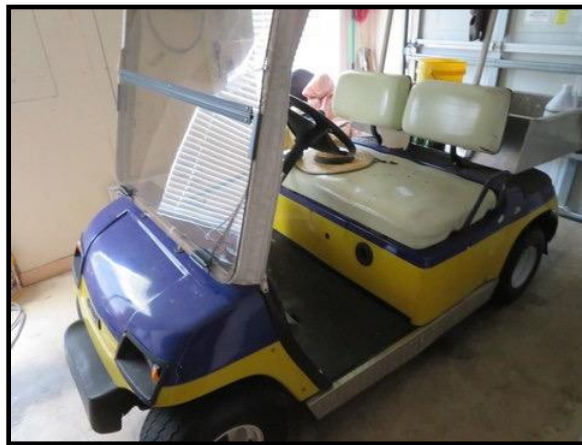
Figure 1

Bayou Pass Village maintains a golf cart. The golf cart is mostly original to the community and in fair reported condition. The golf cart has an estimated useful life of up to 20 years based on its usage. The Association should budget for its replacement by 2026 and again. By 2046.

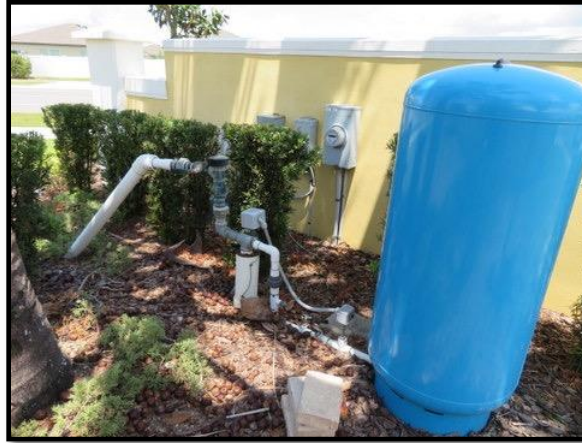
The irrigation system is served by four pump stations. The pump stations vary in age. The pump stations have a useful life from 15- to 20-years. Bayou Pass Village should fund for phased replacements of the pump stations beginning by 2026 and every five years thereafter. The Association should fund motor replacements and pump rebuilding through the operating budget as needed.

Figure 1 – Phase 4 Pump Station

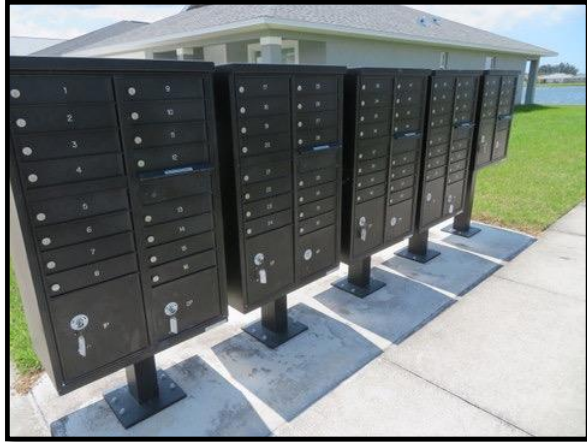
Bayou Pass Village maintains 13 mailbox stations located in Phases 5 and 6. The mailboxes are in good condition at an age of approximately three years. Metal mailboxes have a useful life of up to 25 years. The Association should budget for replacements by 2044.

Figure 1 – Phase 5 Mailboxes

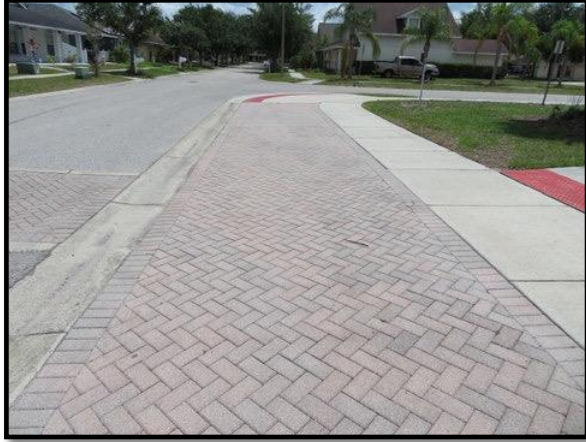
Figure 1 – Street Pavers

The Association should fund for replacement of the street pavers by 2028 and again by 2050. Bayou Pass Village should also fund for replacement of the walkway pavers by 2036.

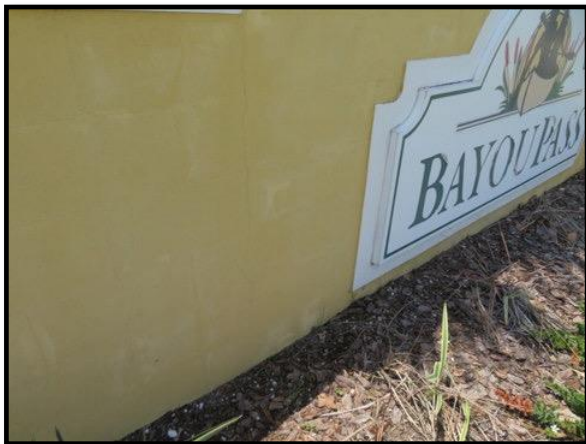
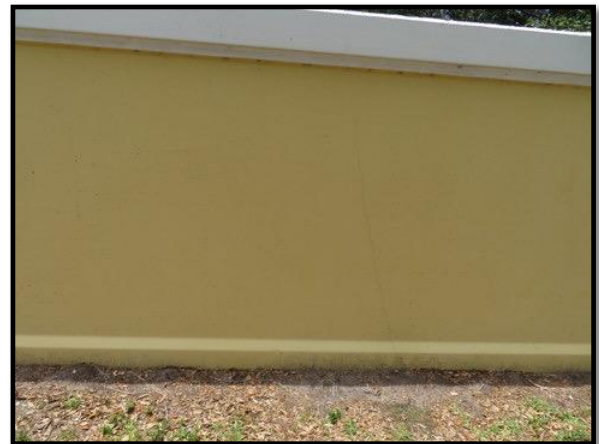
The Association maintains approximately 7,080 linear feet of perimeter walls. The perimeter wall finish is in fair condition overall at various ages. Areas of cracks, faded, and chalky paint are noted. Perimeter walls have a long useful life with the benefit of periodic maintenance. Periodic maintenance includes crack repairs as needed followed by paint finish applications every five- to seven-years. Bayou Pass Village should budget for a paint finish application by 2024 and every seven years thereafter.

Figure 1 – Faded Paint

Figure 2 – Wall Crack

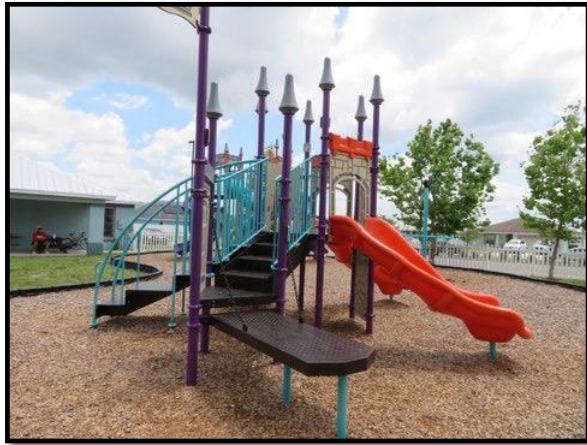
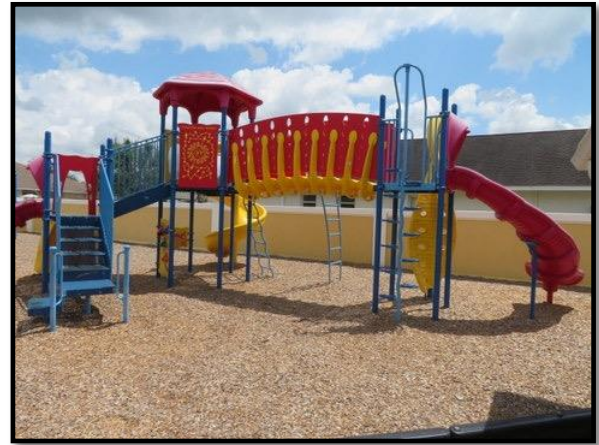
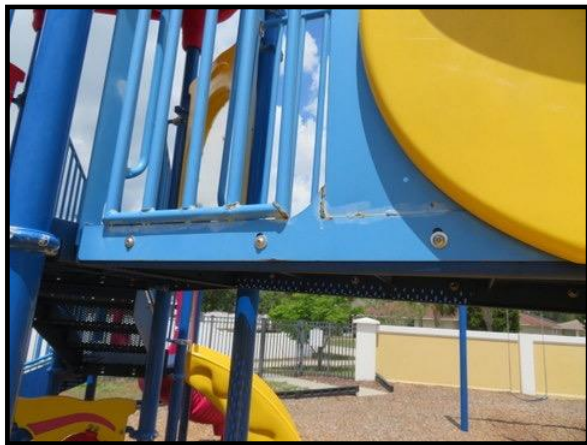
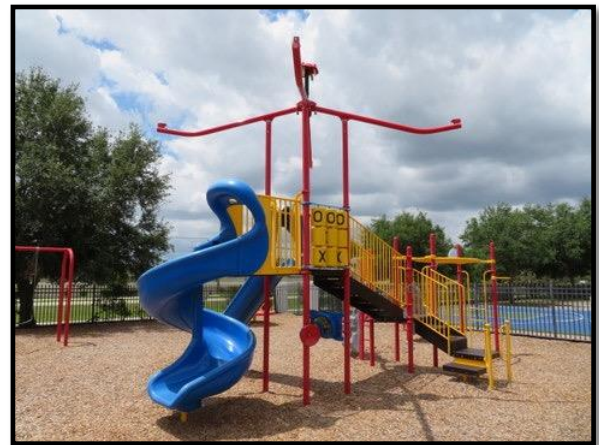
Figure 1 – Blossom Bayou Playground

Figure 2 – Dorothy Duke Playground

Figure 3 – Dorothy Duke Playground Corrosion

Figure 4 - Peaceful Palm Playground

The Association should budget for replacement of the Blossom Bayou playground by 2037. Bayou Pass Village should also budget for replacement of the Dorothy Duke playground by 2026 and again by 2046. The Association should consult with a professional to ensure proper space between each apparatus and a proper landing area. Bayou Pass Village should also budget for replacement of the Peaceful Palm playground by 2031 and again by 2051.

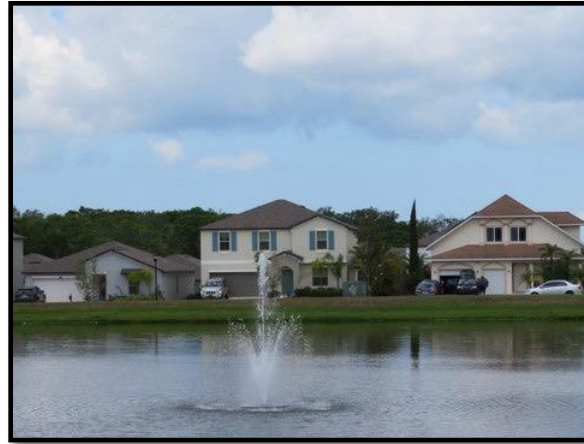
Figure 1

The Board reports that the Association repaired the fountain since the last 2020 Reserve Study Update. We include an allowance for replacement of the pond fountain by 2025 and every 12 years thereafter.

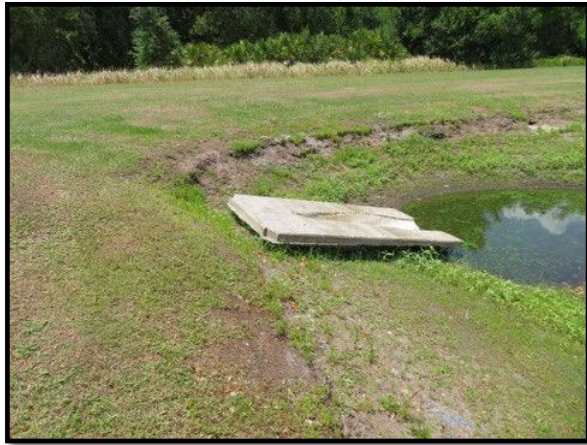
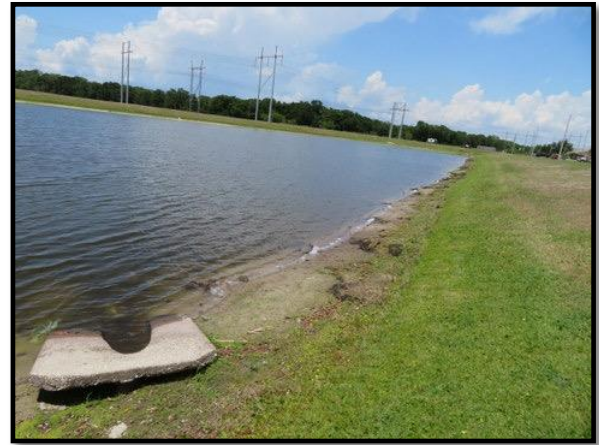
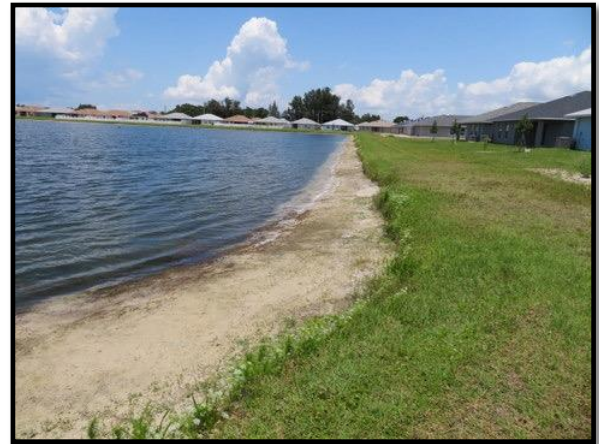
Figure 1 – Phase 1 Pond Erosion

Figure 2 - Phase 2 Pond Erosion

Figure 4 - Phase 5 Pond Erosion

Bayou Pass Village should budget for erosion control of up to ten percent (10%) of the shorelines every 15 years beginning in 2024 based on the age and condition of the ponds.

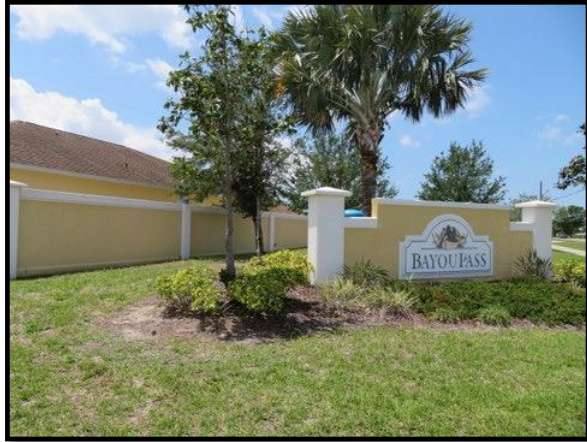
The Association maintains monument signage located throughout the community. The Board reports that Bayou Pass Village is currently renovating the monument signage as needed. Entrance monuments contribute to the overall aesthetic appeal of the property. Renovations are based on the desire to update the perceived identity of the community. Therefore, the timing of renovations is discretionary. We recommend the Association budget for phased renovations of the entrance monuments by 2033 and every 10 years thereafter.

Figure 1 – Typical Monument Signage

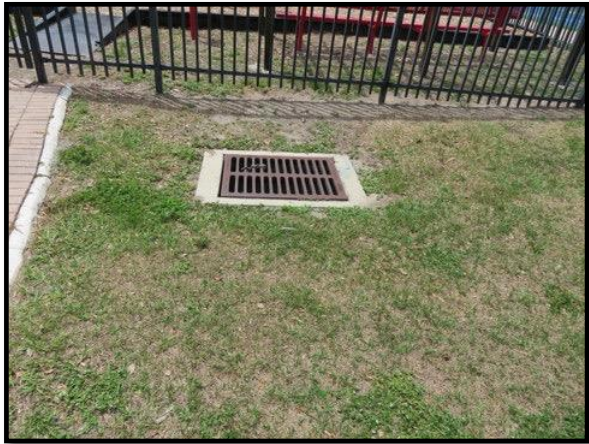
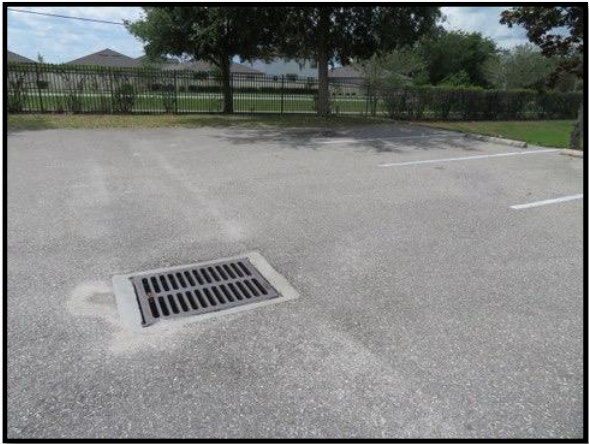
Figure 1 – Catch Basin

Figure 2 – Catch Basin
